movemachiner | HOME REPORT

34 Glebe Road
ARBROATH
DD11 4HJ
06/08/2020

Single Survey

Property address	34 Glebe Road Arbroath DD11 4HJ
Customer	Mr R Scott
Customer address	C/o Find My Buyer 2 Lower Hall Street Montrose DD10 8JW
Prepared by	J & E Shepherd
Date of inspection	4th August 2020

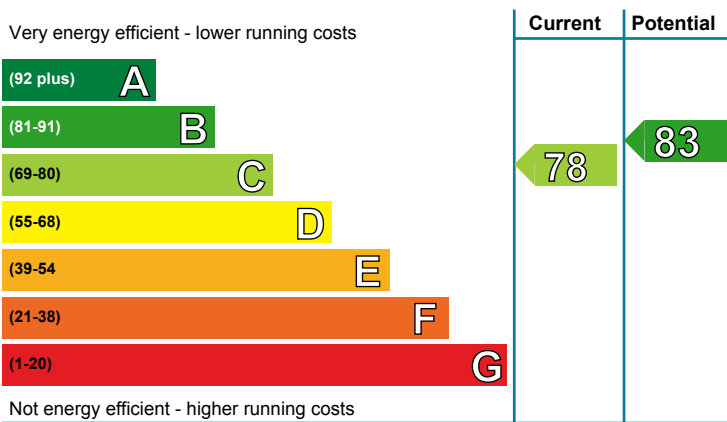
Energy Efficiency Rating

This graph shows the current efficiency of your home, taking into account both energy efficiency and fuel costs. The higher this rating, the lower your fuel bills are likely to be.

Your current rating is **band C (78)**. The average rating for EPCs in Scotland is **band D (61)**.

The potential rating shows the effect of undertaking all of the improvement measures listed within your recommendations report.

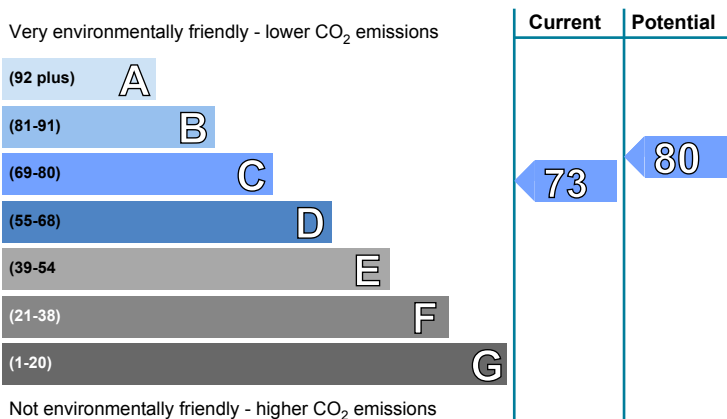
Environmental Impact (CO₂) Rating

This graph shows the effect of your home on the environment in terms of carbon dioxide (CO₂) emissions. The higher the rating, the less impact it has on the environment.
