movemachine | HOME REPORT

11 Southesk Place
Ferryden
MONTROSE
DD10 9RL
10/02/2021

Single Survey

Property address	11 Southesk Place Ferryden MONTROSE DD10 9RL
-------------------------	---

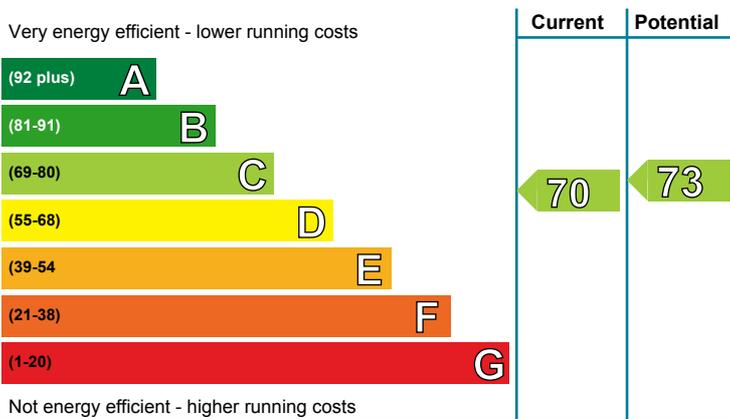
Energy Efficiency Rating

This graph shows the current efficiency of your home, taking into account both energy efficiency and fuel costs. The higher this rating, the lower your fuel bills are likely to be.

Your current rating is **band C (70)**. The average rating for EPCs in Scotland is **band D (61)**.

The potential rating shows the effect of undertaking all of the improvement measures listed within your recommendations report.

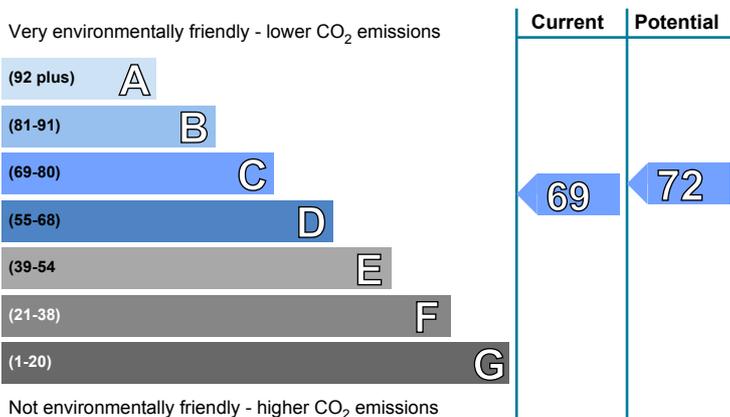
Environmental Impact (CO₂) Rating

This graph shows the effect of your home on the environment in terms of carbon dioxide (CO₂) emissions. The higher the rating, the less impact it has on the environment.
